### 1. Introduction

This document is intended to provide guidance in the selection and maintenance of Ex certified electrical equipment so that the specific issue of corrosion is considered by personnel in all stages of the life-cycle of Ex equipment.

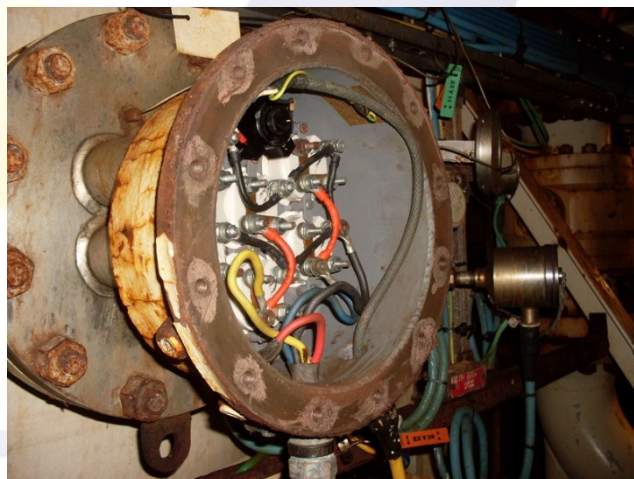
Figure 2 - Same heater as Figure 1, showing acceptable internal condition

The following examples illustrate that an internal inspection is required to assess the level of corrosion. The first example in Figure 1 shows a process heater Ex'd' terminal box with a relatively high level of external corrosion. However on internal inspection, the condition of the flame paths, the internals of the terminal box, and the wall thickness of the enclosure were all considered acceptable.

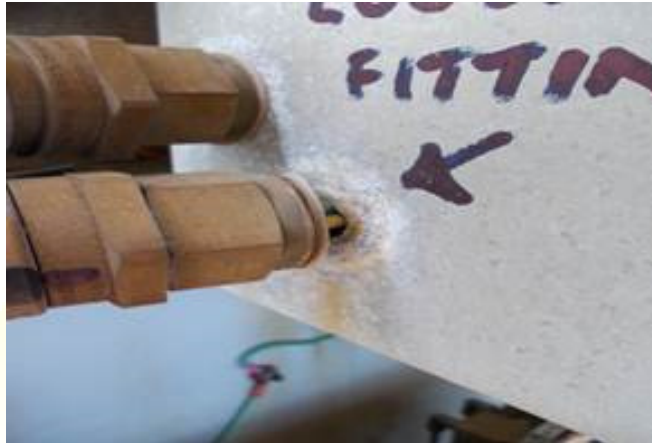
Figure 3 - Example Showing Aluminium Alloy Corrosion which has caused brass adaptor threaded section to break off.

- Seals and 'o' rings fail resulting in water ingress.
- The expansion results in fasteners becoming stuck, for example stainless steel bolts in alloy lids, or brass glands and adaptors becoming 'welded' into threaded entries (see example in section 5).

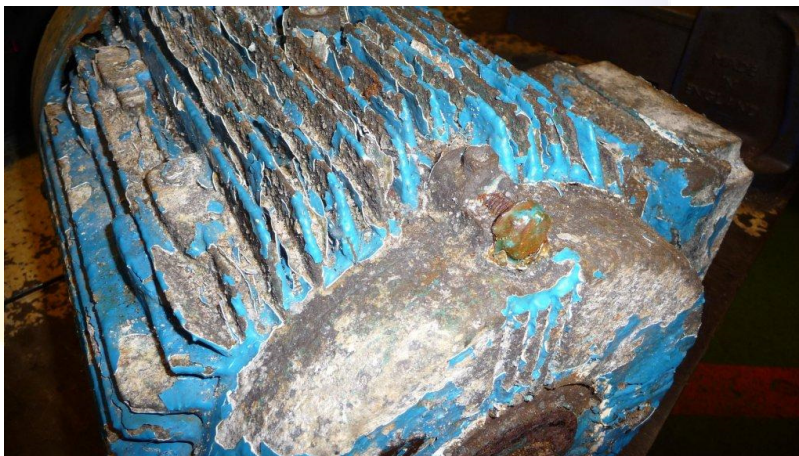
Figure 4 - Example of corrosion of aluminium motor housing
